March 7, 2011

My examination of your home showed a need for the following modifications:

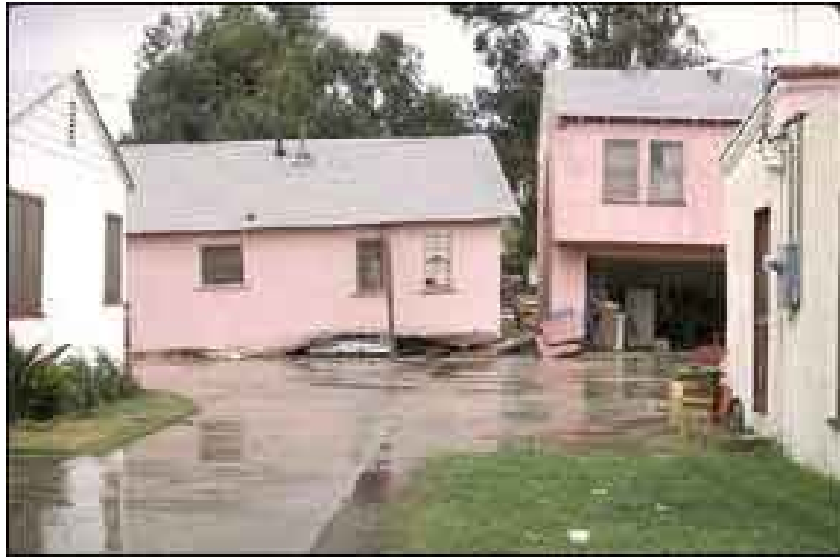
FINDING: This home has living area above a garage. The floor above the garage door opening has nothing under it to prevent the floor from swaying back and forth and possibly even collapsing.

Garage Door Openings Represent a Serious Structural Weakness

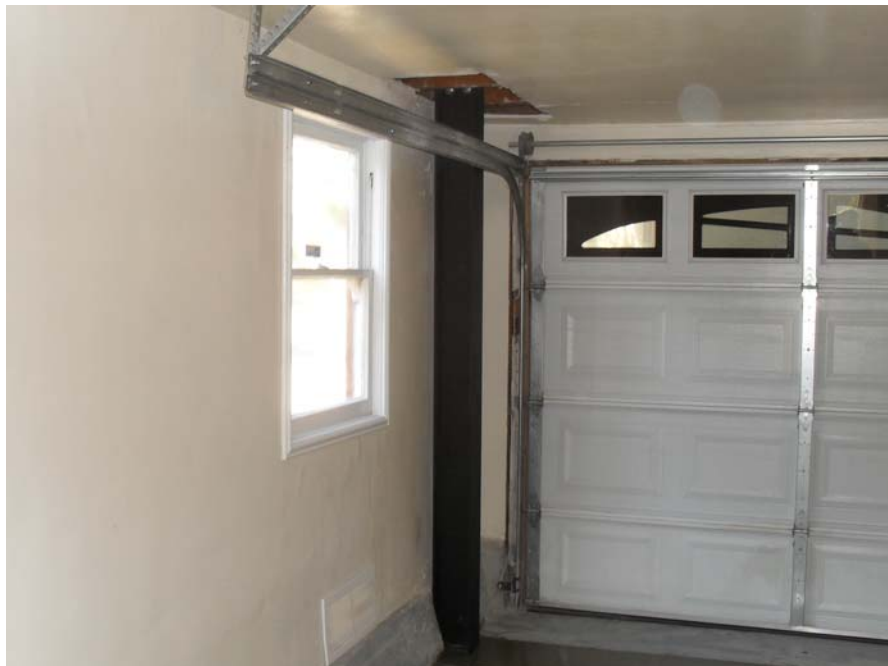
Embedding a very rigid large steel beam into concrete and attaching it to the floor above the garage door opening addresses this weakness. These are known as moment columns

RECOMMENDATON: Where shown on the enclosed drawing, install a 500 hundred pound 12 inch by 8 inch by 3/16 inch steel column which will be embedded in concrete at its base and attached to the floor at the top.
