Part 3

Understanding Your Retrofit

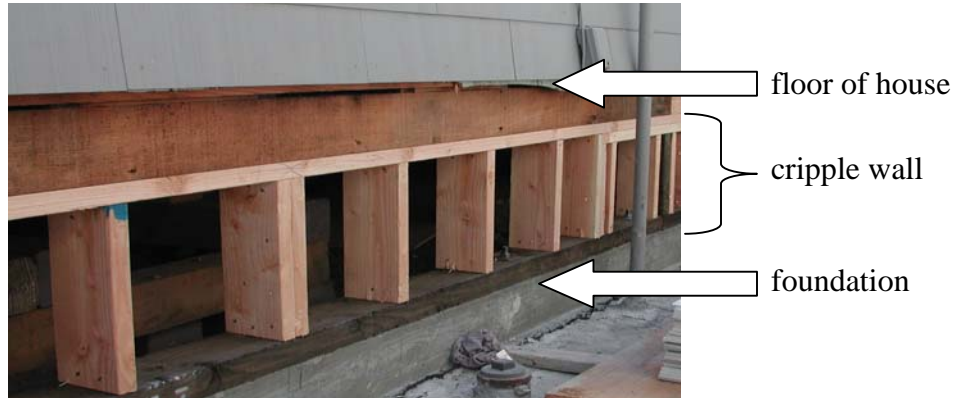
A typical cripple wall seen from the outside
Photo courtesy Summerfield Inspections, Berkeley

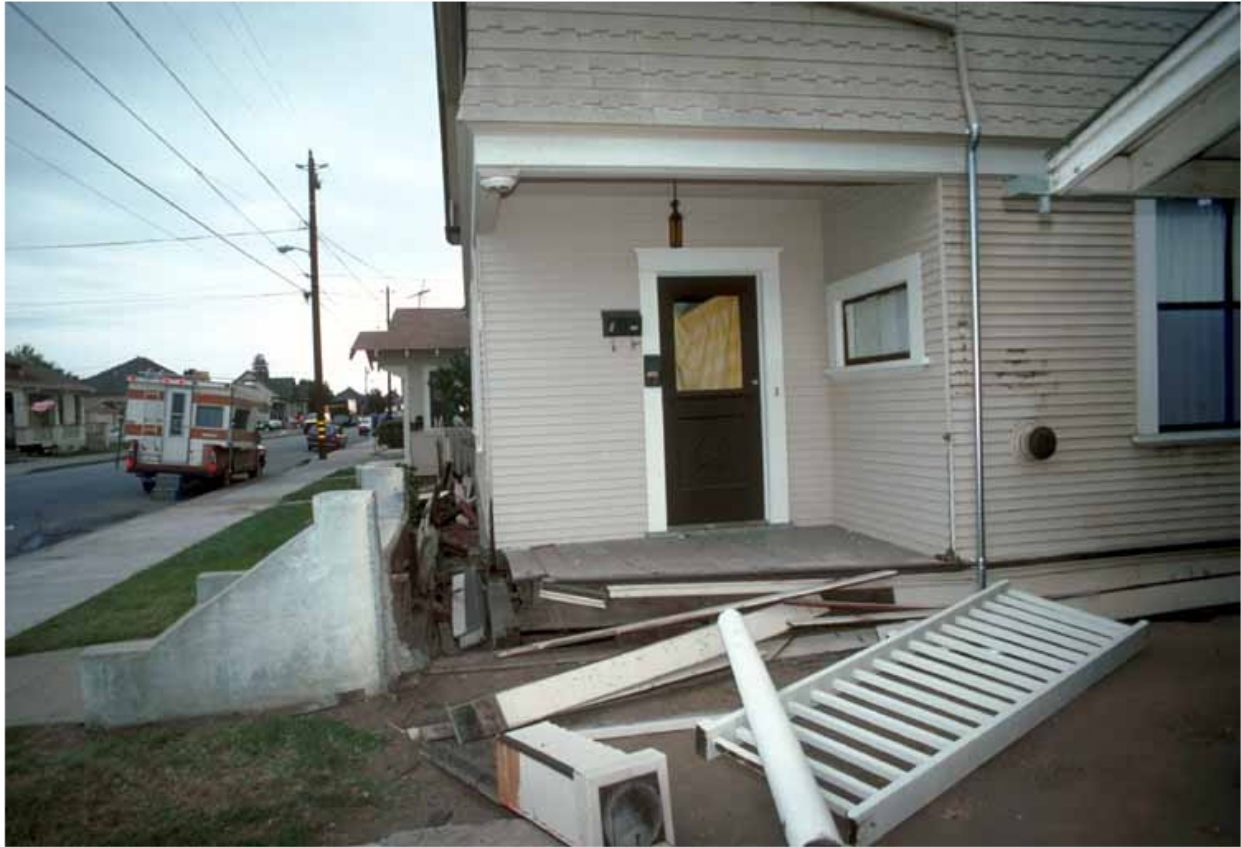
This house in Watsonville fell off its foundation because the cripple walls collapsed in the 1989 Loma Prieta earthquake. This would not have happened if the cripple walls had been retrofitted.

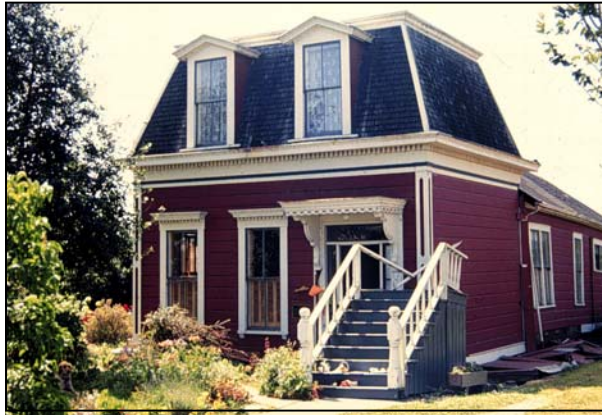
Example 1: Cripple wall failure; notice the location of the steps relative to the floor.

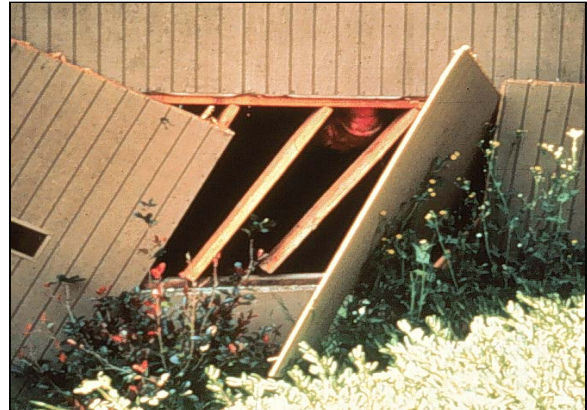
Example 2: Cripple wall failure where the floor shifted to the right..

The house on the left has fallen from its foundation but is otherwise intact. This house in Ferndale California suffered extensive interior damage and needed to be torn down. This damage would have been avoided if it had been retrofitted.

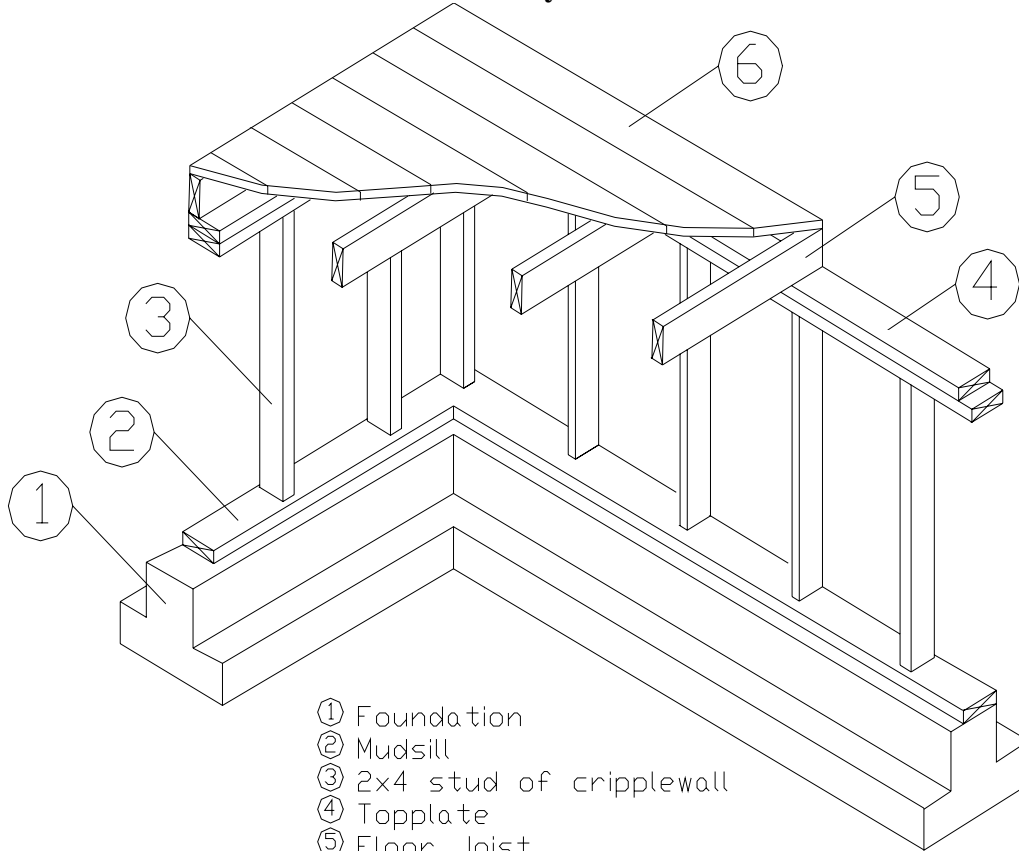
Glossary of useful terms

- ① Foundation
- ② Mudsill
- ③ 2x4 stud of cripplewall
- ④ Topplate
- ⑤ Floor Joist
- ⑥ Floor you walk on

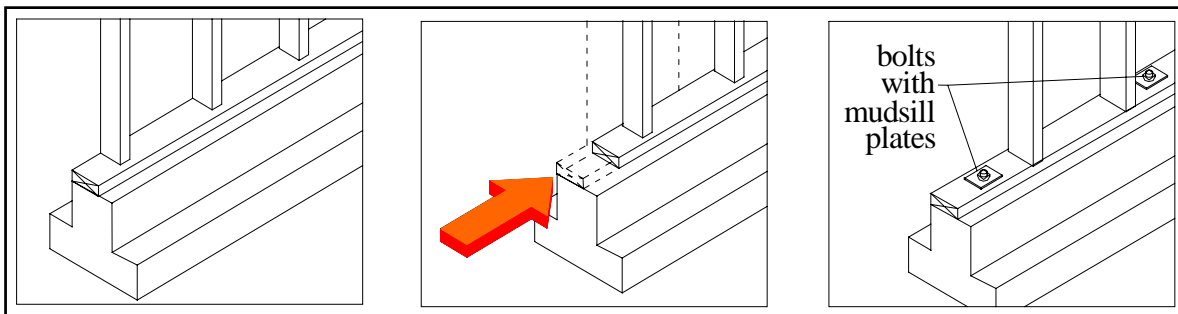
The arrow represents the earthquake force moving the bottom of the cripple wall. The third frame shows the bolts that prevent this movement.

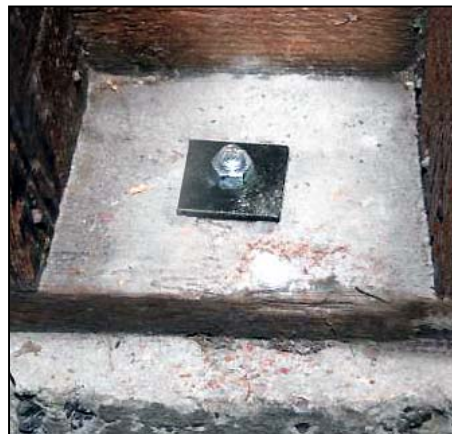
Bolt with plate washer passing through mudsill and into foundation.

Structural engineers in Southern California discovered that bolts bent in earthquakes and that this split the mudsill. These same engineers discovered that plate washers as shown below prevent this from happening.

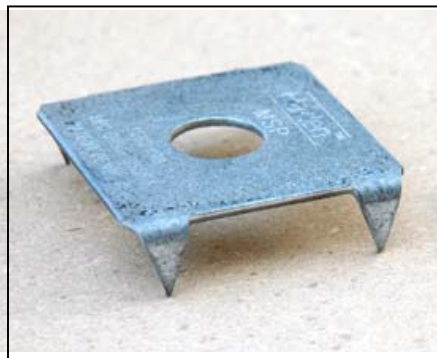
Mudsill Plate

These engineers also discovered that mudsills often split because when the earthquake force pushed on the mudsill against the bolt, the wood was much softer than the bolt or the concrete. They developed a special type of washer called a mudsill plate that not only helps with spitting, but also increases bolt strength by 59% to 200%. Bay Area Retrofit is the only company that uses these special washers.

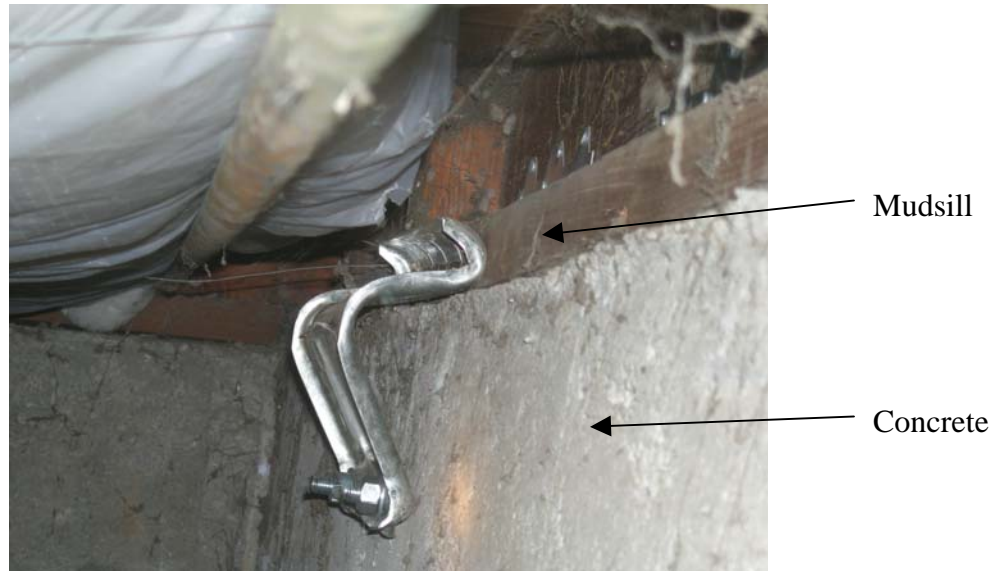
Foundation Anchor

Sometimes there is no room to install a bolt because the distance from the mudsill to the floor you walk on is too short for a concrete drill. In these cases a foundation anchor is bolted to the side of the concrete and the side of the mudsill.

Foundation anchors, as shown in the photo below, are used to attach the mudsill to the concrete foundation. They are stronger than a standard bolt.

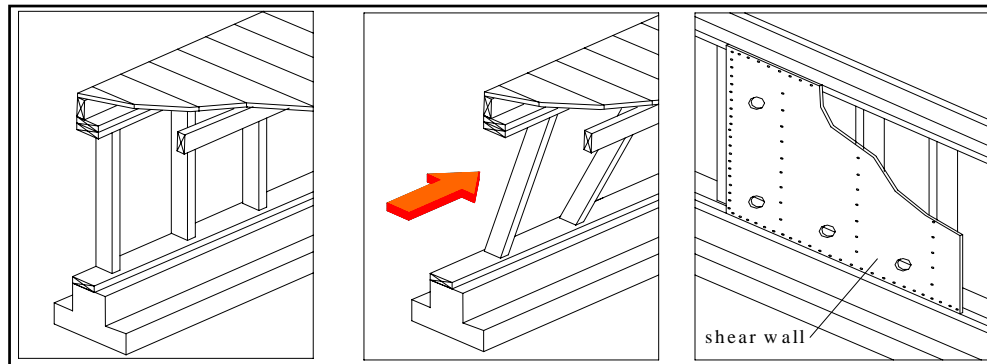
The red arrow in the center drawing shows how earthquake forces push on the cripple wall, causing it to collapse. The last drawing shows how we install plywood to prevent it from collapsing. Even though this drawing makes plywood installation look very simple, entire manuals and even books have been written on this subject

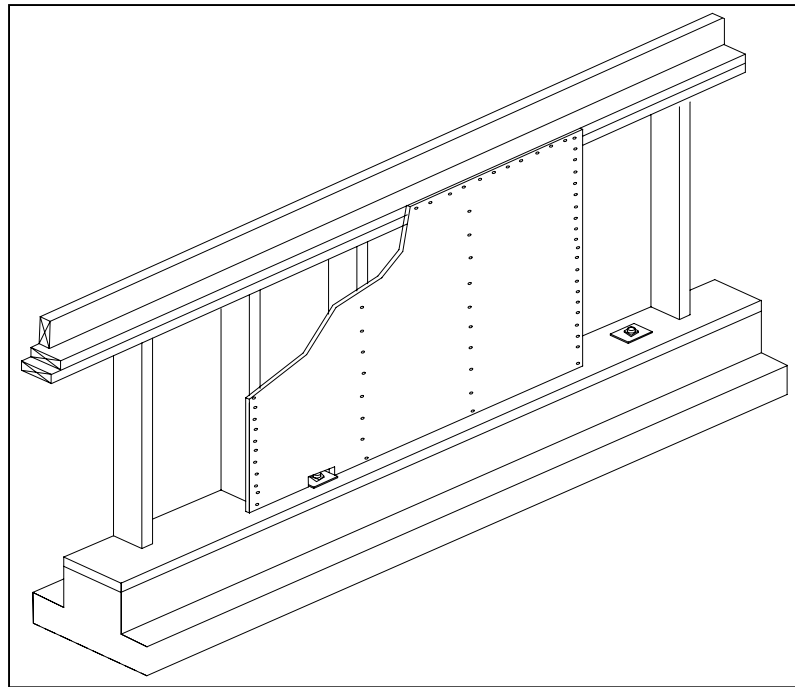
Use the flush cut method

Your home is built with mudsills that are 6 inches wide supporting 4 inch wide two by fours. As shown above, unless a modification is made, the plywood will sit on top of the mudsill where it will not be connected to the bolts. One method is the flush cut method. This is the method Bay Area Retrofit uses and is the only company in the Bay Area that does so

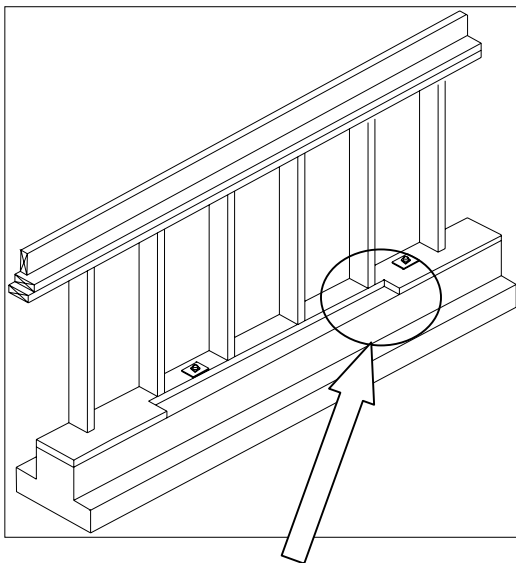
Mudsill is cut flush with the 2 by 4s

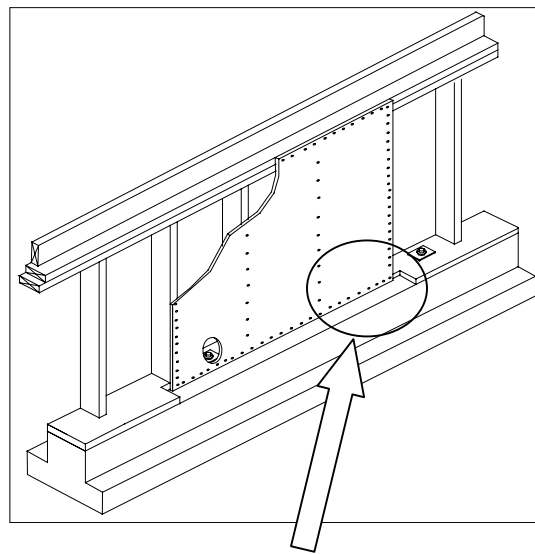
Plywood is nailed to the bolted mudsill.

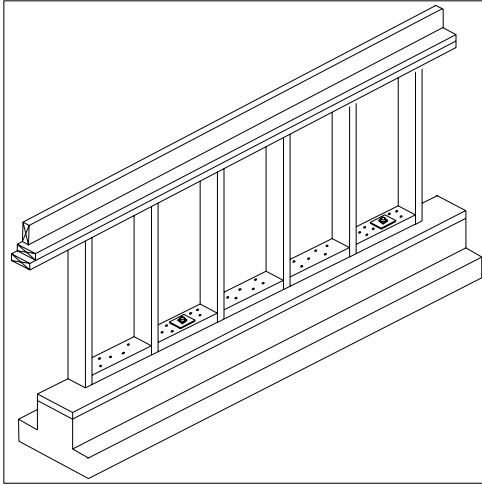
Another method is to install wooden blocks between the 2 by 4s and then nail the plywood to the blocks.

Blocks nailed between 2 by 4s

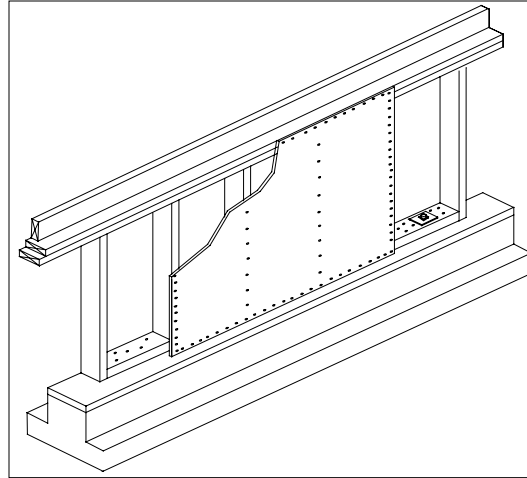
Plywood nailed to the blocks

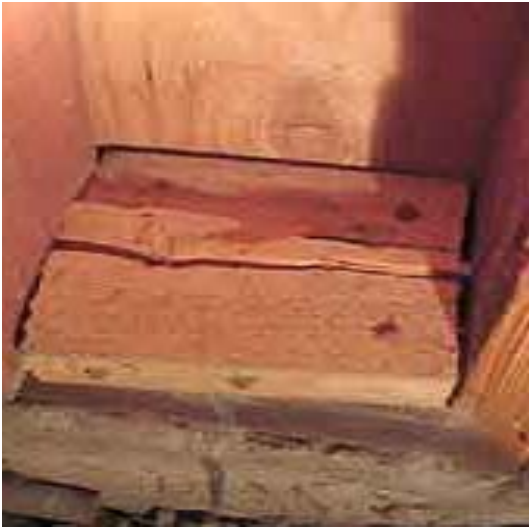
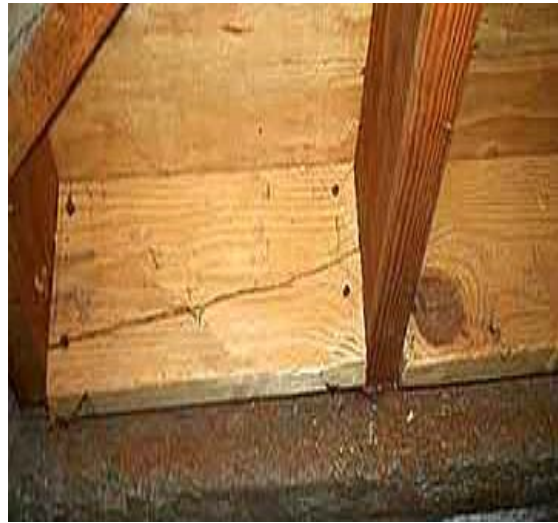
This method often splits the blocks.

We never use nailed wood blocks. This method has only been tested once and was found to produce shear walls that are half as strong as shear walls built using the flush cut method.

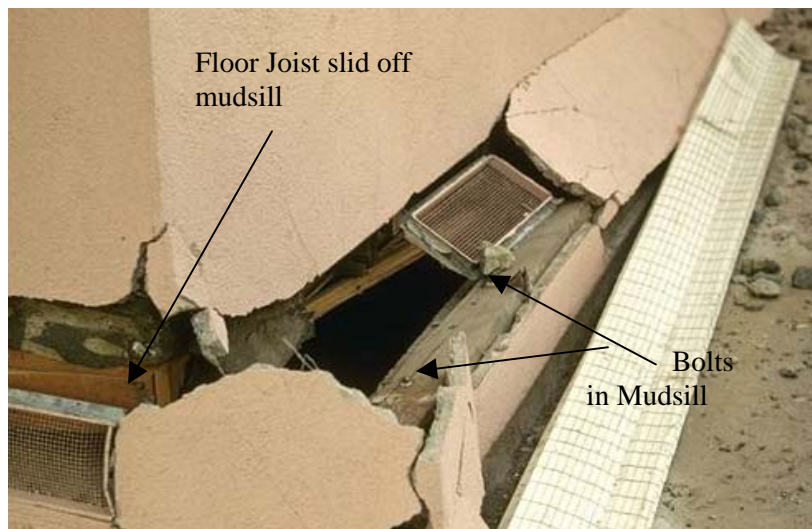
A house without a cripple wall and no shear transfer ties.

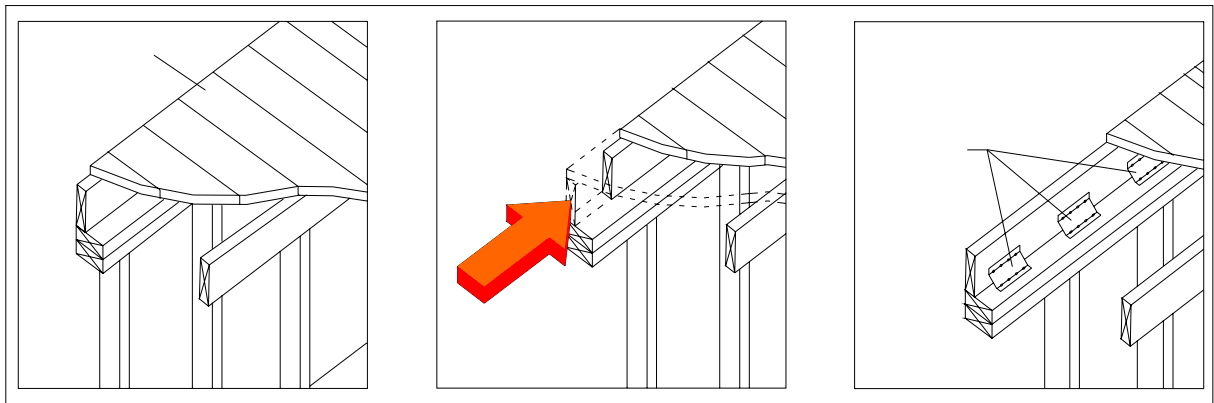
Shear Transfer Ties are a special type of hardware designed to prevent the floor framing from moving on top of the cripple walls.

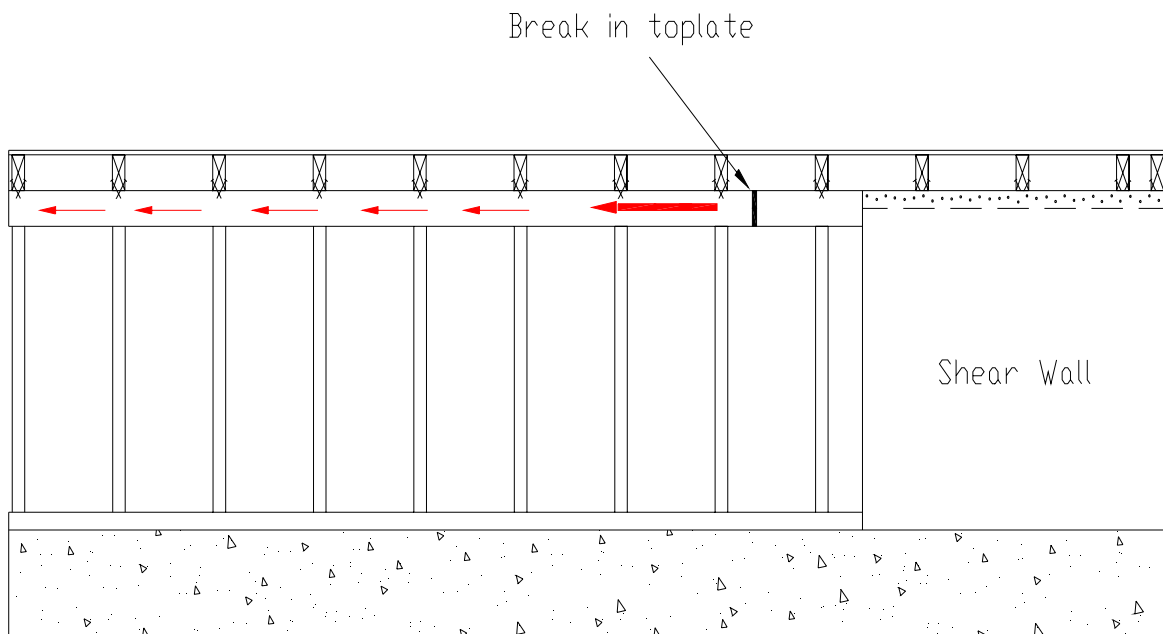
It is important to make sure any breaks in the top plate are spliced together. The red arrows represent earthquake forces pulling on the cripple wall and trying to pull the floor along with it. This movement would cause damage if it were not restrained by the shear walls. In order for these forces to make it into the shear wall, the Break in Topplate must be joined together with nails or a steel strap placed over it. In this way earthquake forces traveling through the top plate are transferred through the break in top plate and into the shear wall.

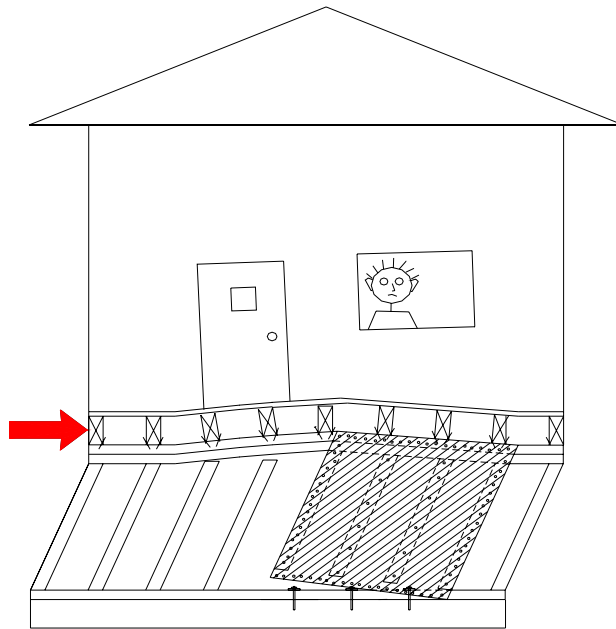
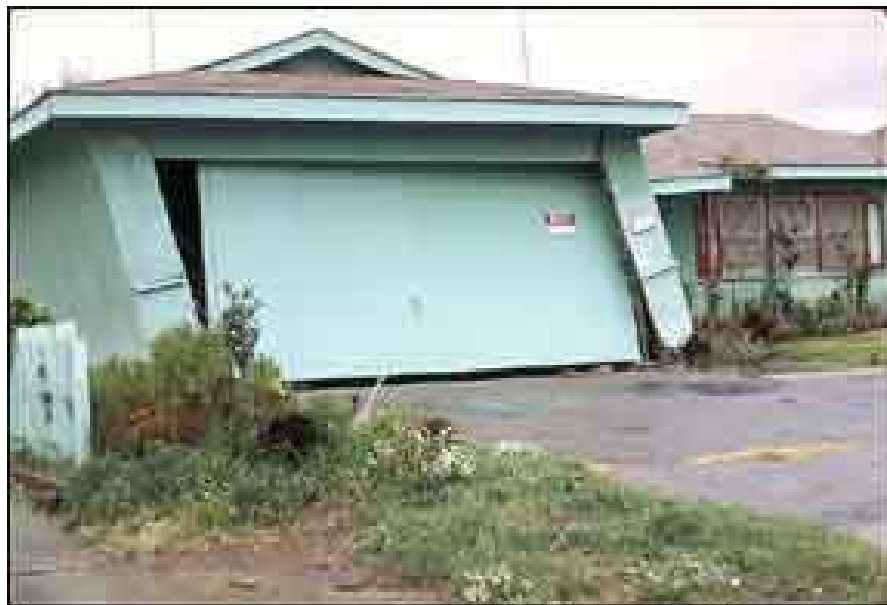
A shear wall can tip over when an earthquake force shown by the red arrow pushes on the floor. This is especially true for tall shear walls. Hold downs prevent this from happening.

Shear walls on either side of a garage with overturning damage
Install Steel Cantilever Column

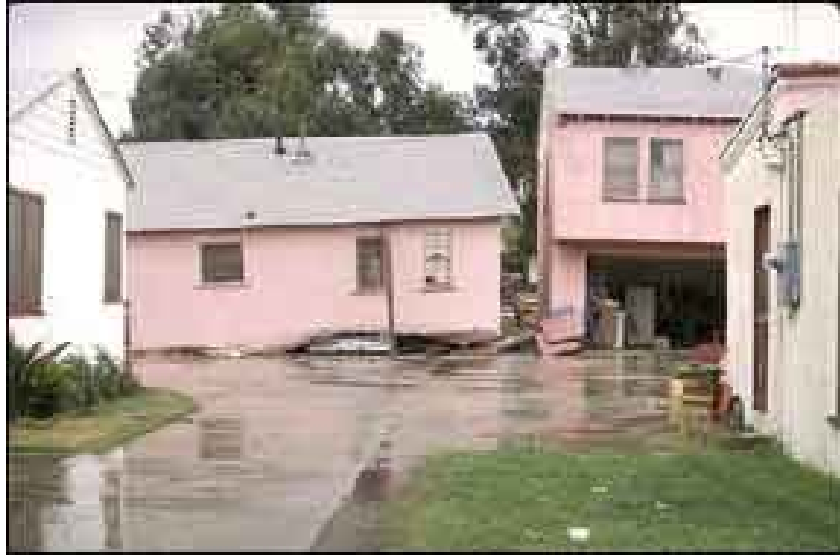
Embedding a very rigid large steel beam into concrete and attaching it to the floor above the garage door opening addresses this weakness. These are known as moment columns

Garage Door Openings Represent a Serious Structural Weakness

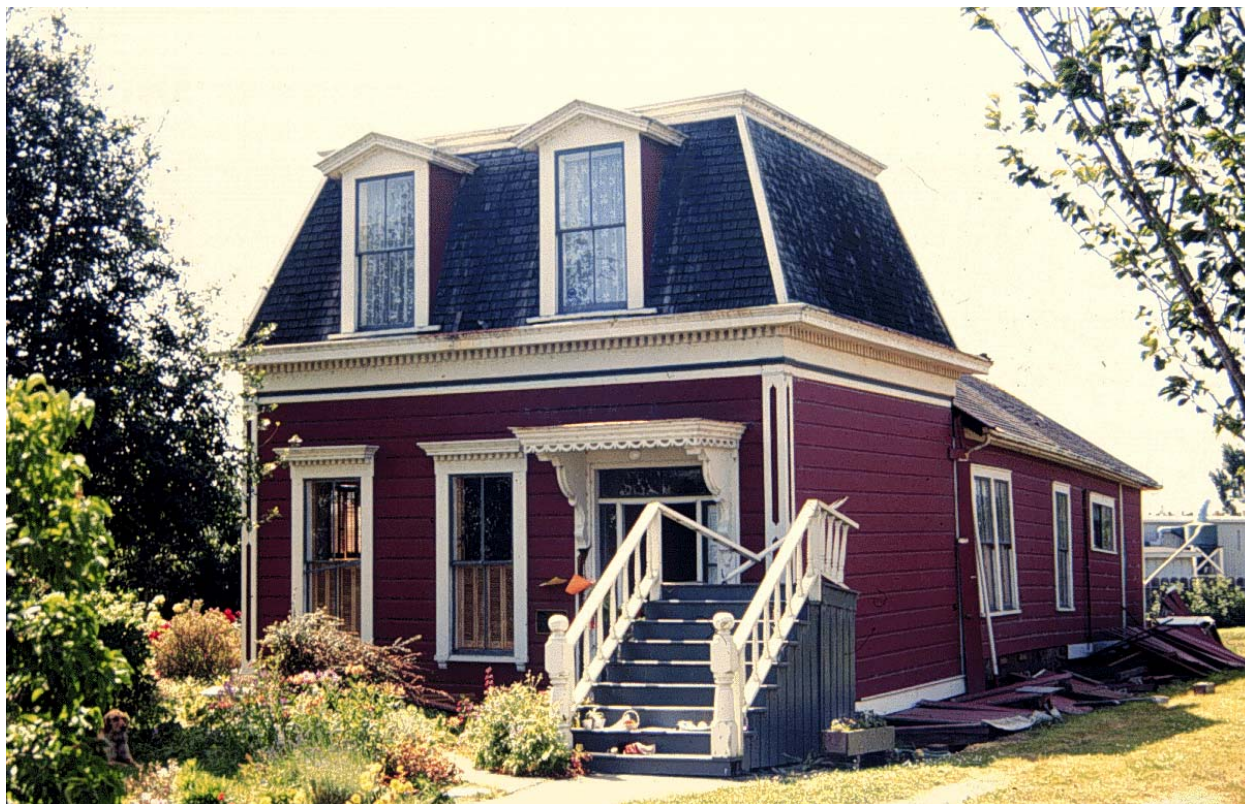
Notice the top of the stairs of this home relative to the position of the floor. This home fell six feet in a 7.1 earthquake in Ferndale California. None of the windows are cracked and the house is fully intact in every way except the damage to the interior was so extensive it needed to be torn down. The damage to this home would have been quite minimal if it had been retrofitted and not fallen off its foundation.
