Foundations and Footings

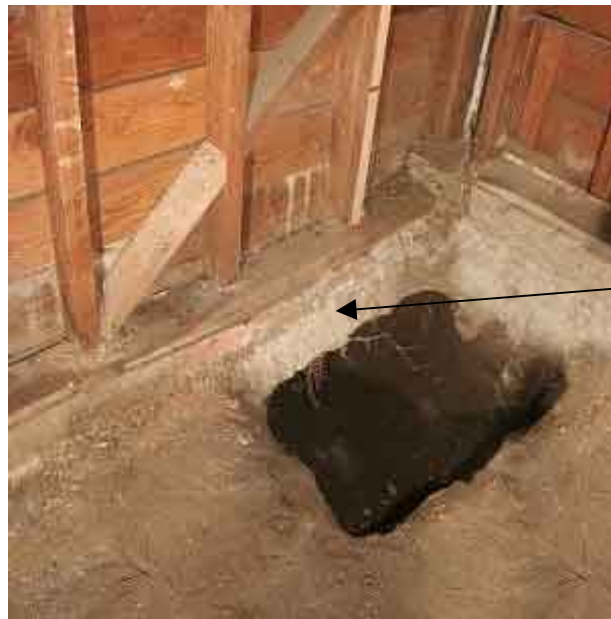
Figure 3

Old Foundation, 6 inches tall, 4 inches embedment, 10 inches wide.

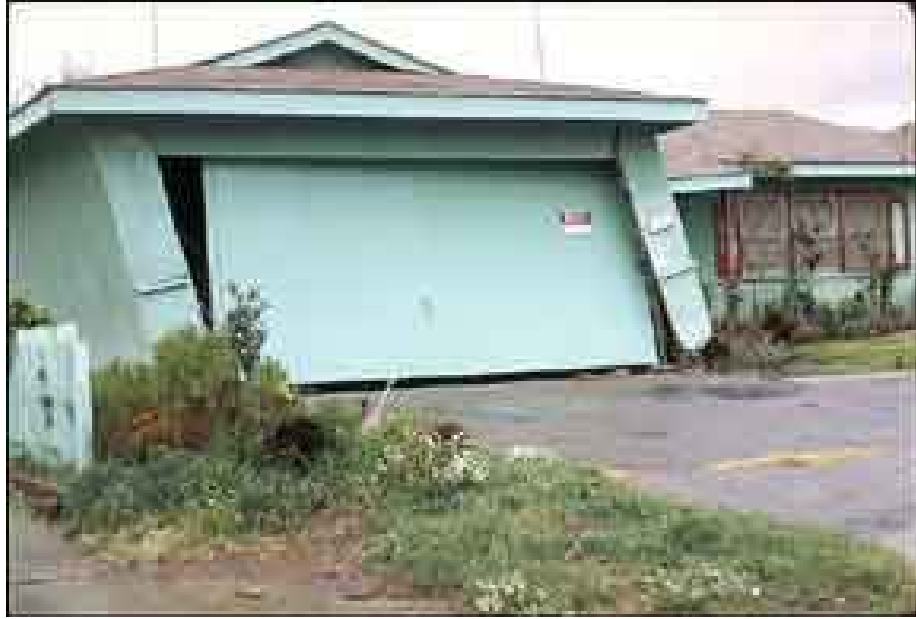
The photo below demonstrates how, just like with the chest, the tendency to overturn is much greater in tall narrow shear walls.

The overturning of narrow walls on either side of a garage door opening as shown in Figure 7 is quite common. This occurs more readily when a living area is above the garage because the added weight moving back and forth creates stronger overturning forces.

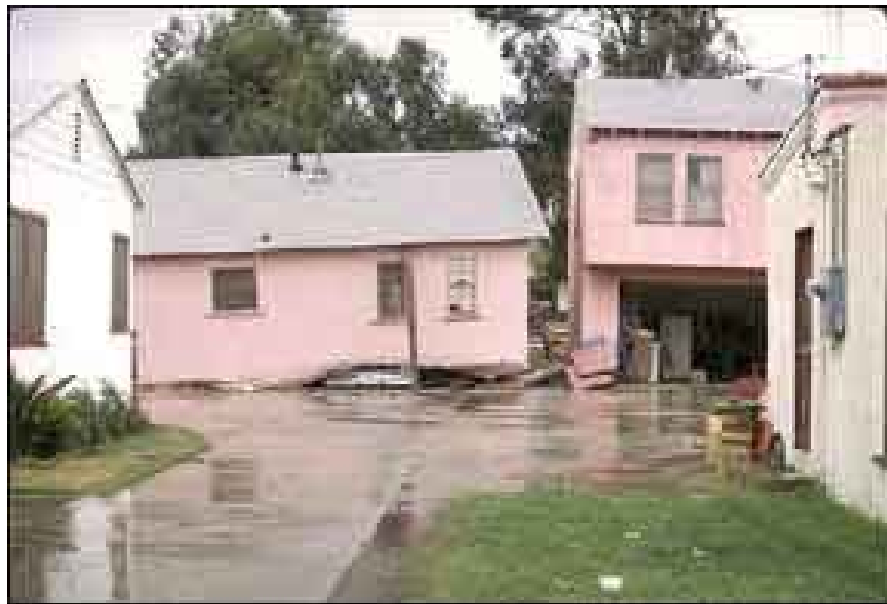
Figure 8

This collapse was caused by overturning of tall narrow shear walls on either side of the garage.

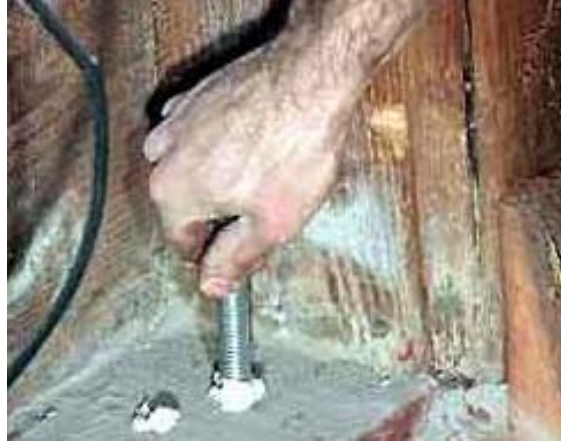
Hold down threaded rod installed with epoxy as deep into the foundation as possible.

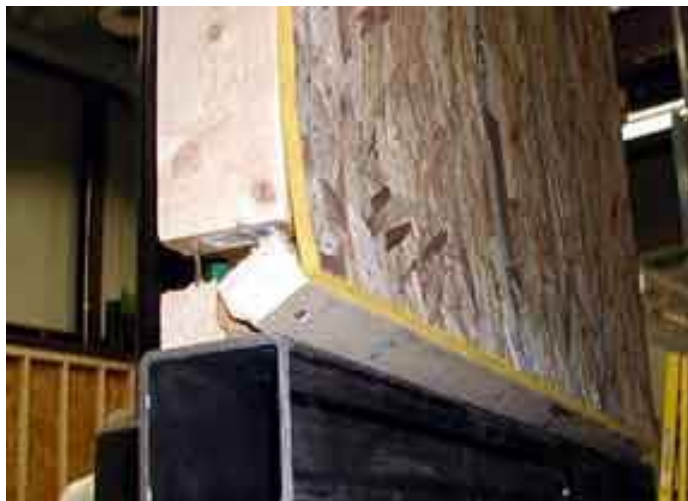
American Plywood Association Shear Wall Test with Cross Grain Bending Failure

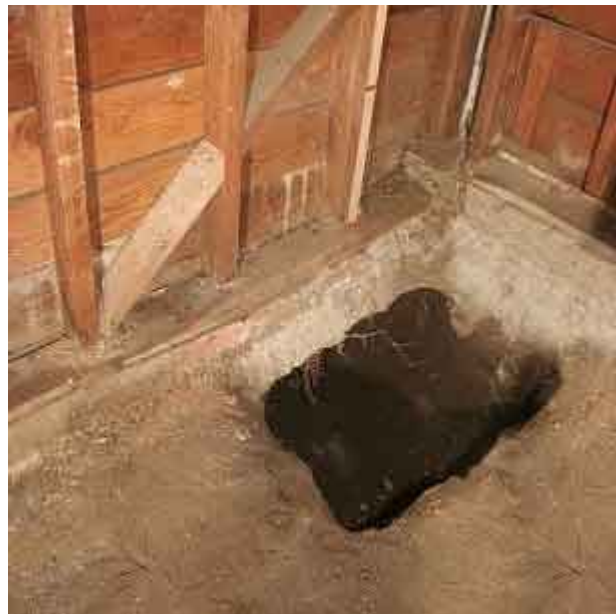
Figure 11

The existing unreinforced concrete foundation shown here is only 8 inches tall and 10 inches wide. This is clearly insufficient to resist the overturning forces that a new 8 foot tall by 10 foot long shear wall will exert on the foundation. In this case the front cripple wall was being

braced by a shear wall this size. A one-cubic yard hole has been dug out under both ends of the shear wall so that these holes can hold 4000 pounds of concrete.

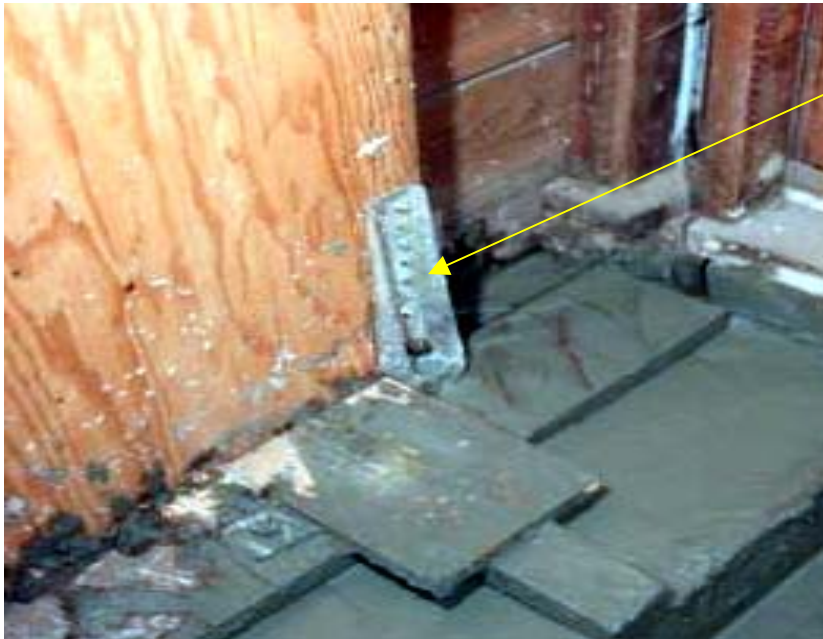
Figure 12

Here is the same view after the concrete has been poured and the plywood installed. An all-thread anchor rod with a nut at its lower end has been cast into each block of concrete to anchor the holdowns to the new concrete.

We now have a complete overturning load path where the weakest element has been reinforced with concrete.

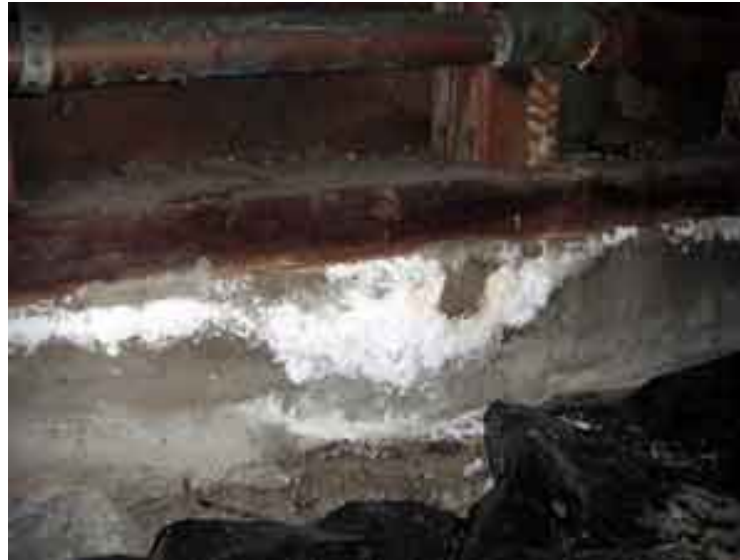
Figure 14
Typical Foundation with Efflorescence

Foundations often have deteriorated concrete surfaces. The deterioration is most often caused, not by a faulty old mix, but by periodic wet-dry-wet-dry exposure to moisture over many years. The mechanism is this: the base of the wall gets wet, and some of the water penetrates the concrete, carrying dissolved salts picked up from the soil, or the concrete **Does concrete have naturally occurring salts on the outside?** When the water evaporates and comes to the surface, the salts are left behind and form salt crystals on the surface of the concrete.

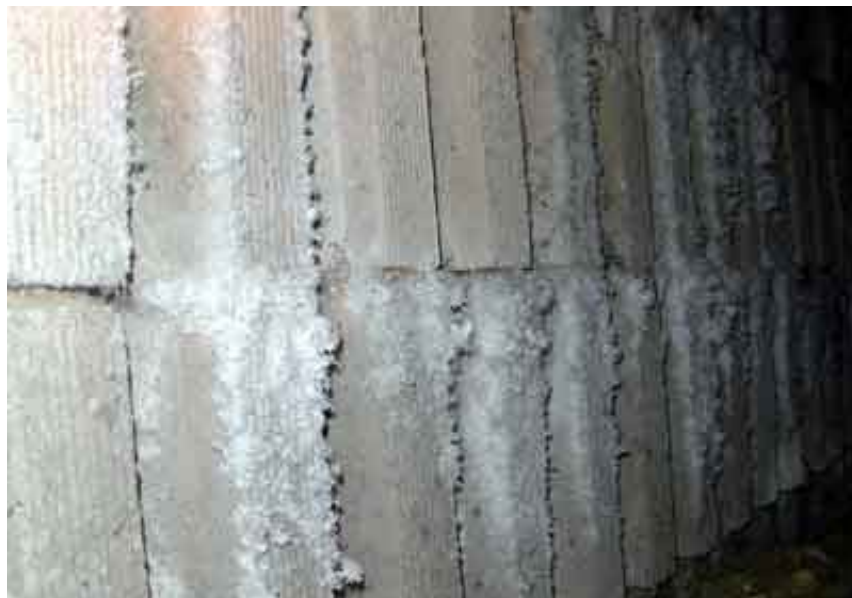
Figure 15 Masonry Blocks with Efflorescent Crystals

As the crystals grow, they exert enough pressure on the surface of the concrete to cause the surface of the concrete to deteriorate. The crystals leave salt deposits on the side of the concrete which have a white powdery appearance (efflorescence).

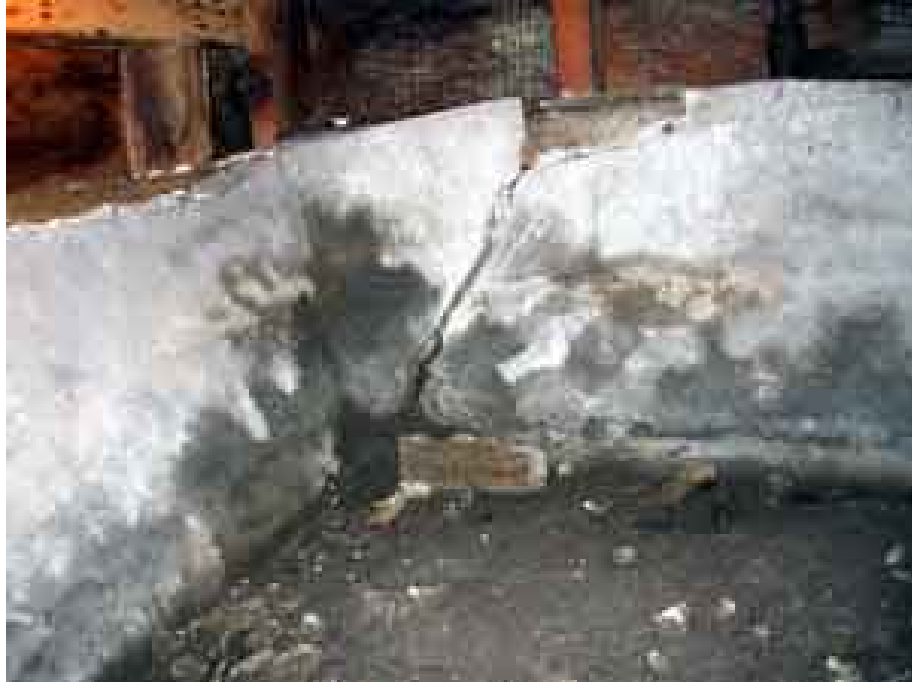
Figure 16

The foundation segment on the left has rotated outward and caused this crack. If this foundation would have been reinforced with steel rebar, such that the rebar wrapped around these foundations segments, this would not have happened.

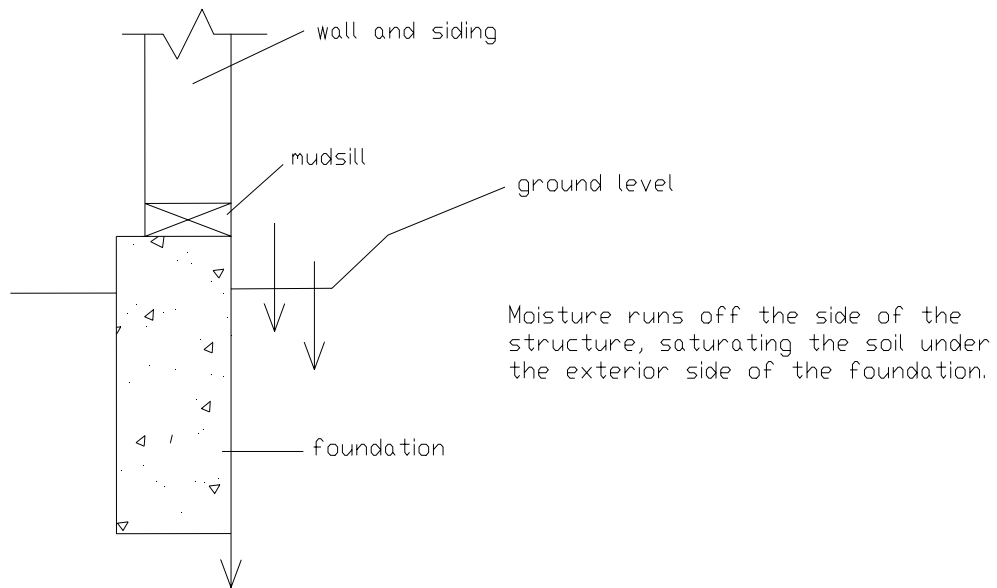
Figure 15

Rotated Foundation

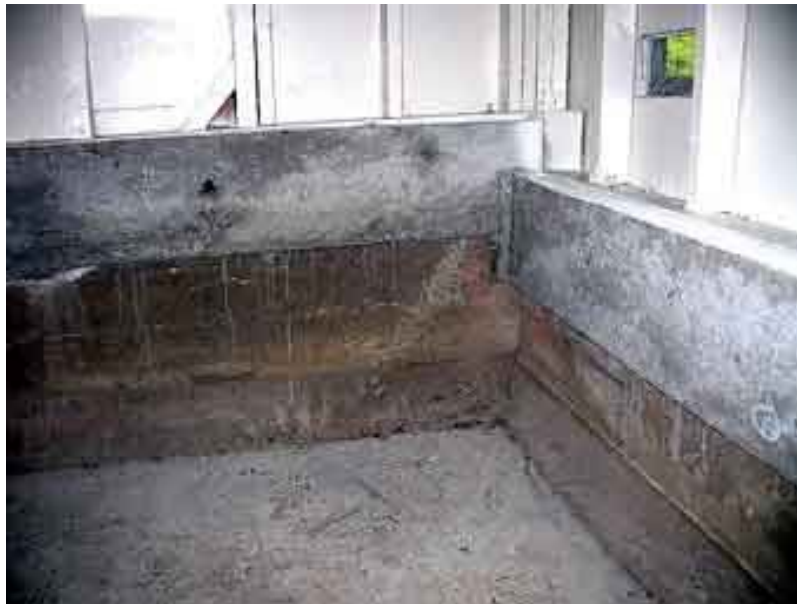
Figure 18

Side view of a foundation cap.

If a retrofit shear wall is built on top of this capped foundation, the cap and old foundation should be pinned together with threaded metal rods. This not only prevents the cap from sliding on the old foundation but on top of the old foundation, but also provides bolts for a future retrofit. Notice how the mudsill is now completely embedded in concrete. This is commonly found in capped foundations. The Nailed Blocking Method discussed earlier is the only method that can be used to provide a surface to nail plywood to.

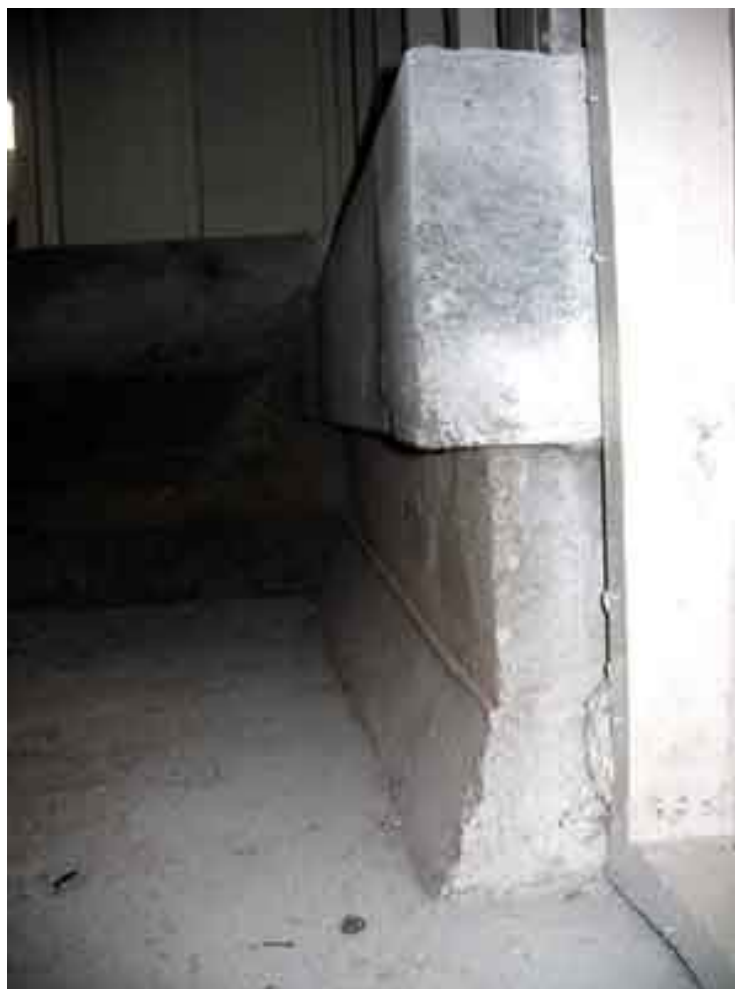
Figure 19

End view of a foundation cap

The concrete underneath this cap appears to be in very good condition and the cap was probably unnecessary so long as the two segments of foundation were connected together with long reinforcing rods..

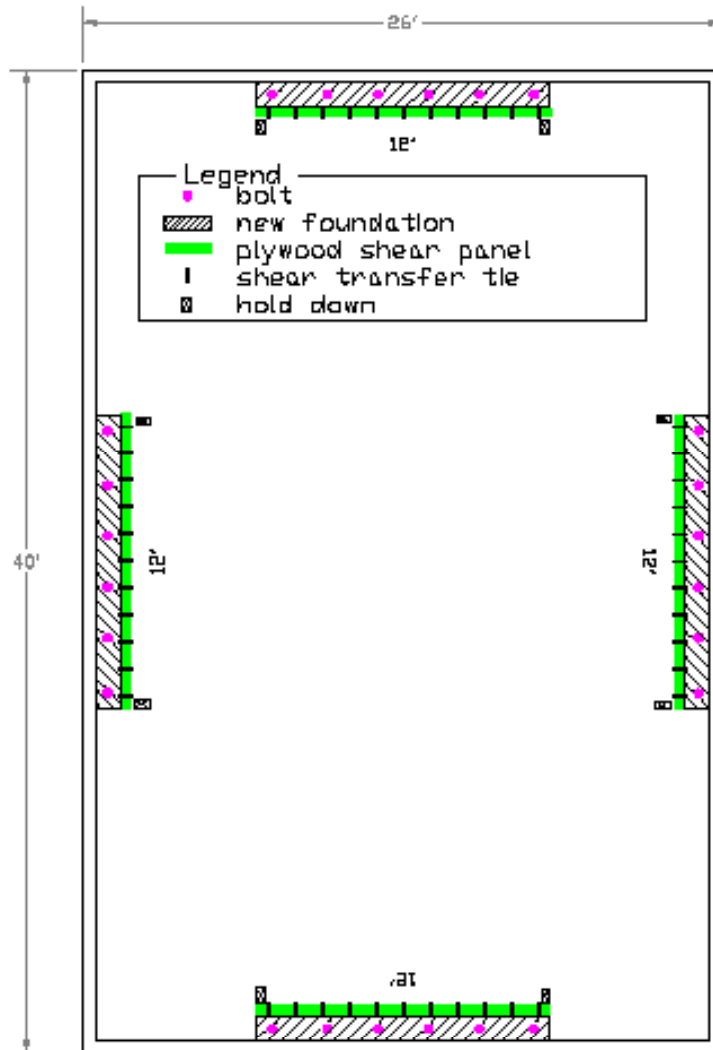
Figure 21

Where serious foundation fractures or deterioration have in fact occurred, and a seismic retrofit is being pursued, foundation replacement or capping is rarely the most cost-effective approach. Segments of new foundation should be poured parallel to the old foundation and all retrofit components built on these new foundations. This is far cheaper than replacement

or capping the old foundation. Below is an illustration of what this would look like. Shear transfer ties are the same as framing anchors that attach the floor framing to the top plate.
